AFRL-RX-WP-TR-2018-0062

MICROSTRUCTURAL AND MECHANICAL CHARACTERIZATION OF 2-D AND 3-D SiC/SiNC CERAMIC-MATRIX COMPOSITES

23 FEBRUARY 2018 Final Report

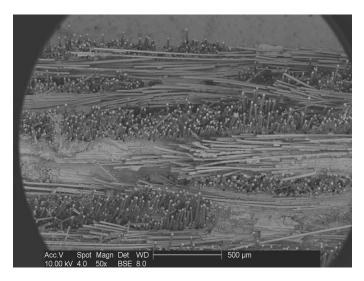
Figure B-1.1.1: SEM Image of 2-D S200, 80 mil @ 50x. This image shows excellent fiber pullout which attest to its strength.

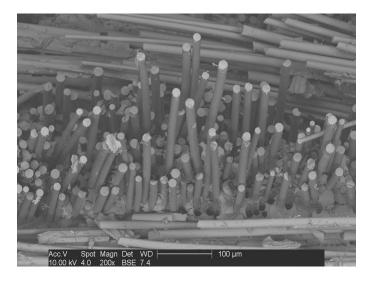
Figure B-1.1.2: SEM Image of 2-D S200, 80 mil @ 200x. A closer look at the fiber pullout in both the fill and tow fibers.

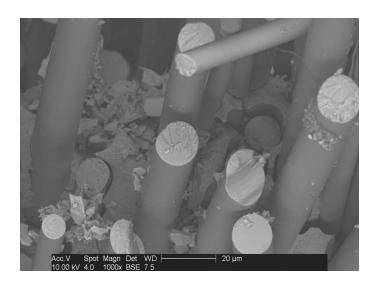
Figure B-1.1.3: SEM Image of 2-D S200, 80 mil @ 1000x. Nice, smooth fractured surface with good separation.

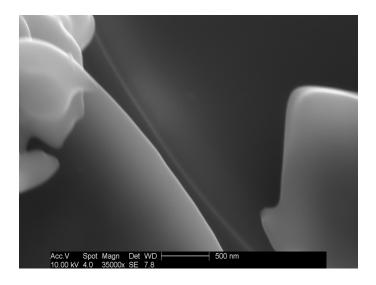
Figure B-1.1.4: SEM Image of 2-D S200, 80 mil @ 35kx. Shows that the fibers are not bonded together.

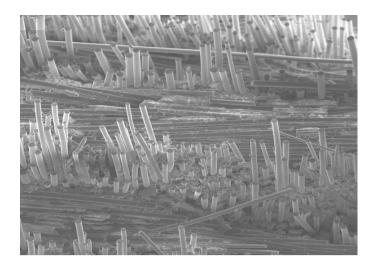
Figure B-1.1.6: SEM Image of 2-D S200, 80 mil @ 150x. Good fiber pullout.

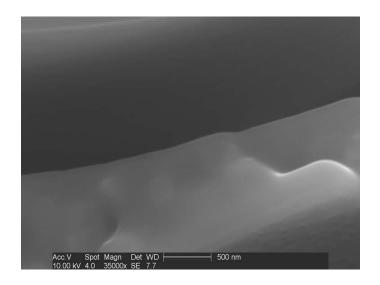
Figure B-1.1.8: SEM Image of 2-D S200, 80 mil @ 35kx. This image shows some spacing between the fiber and the matrix.

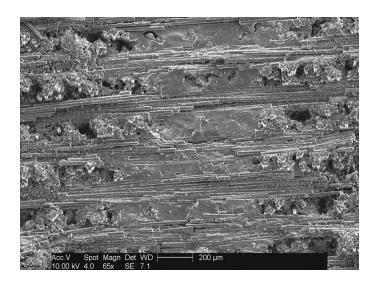
Figure B-1.3.1: SEM Image of 3-D S200, 145 mil @ 50x. This image shows that the fibers failed in same plane.

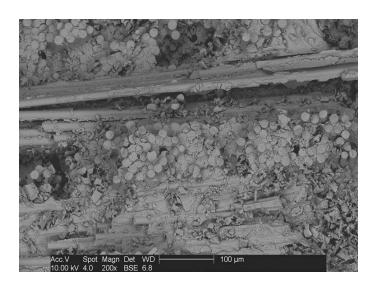
Figure B-1.3.2: SEM Image of 3-D S200, 145 mil @ 200x. Very poor fracture pullout; all fibers failed in same plane.

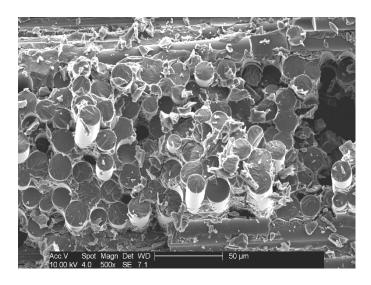
Figure B-1.3.3: SEM Image of 3-D S200, 145 mil @ 500x. Failure seem to be a step function...fibers failed in groups in the same plane.

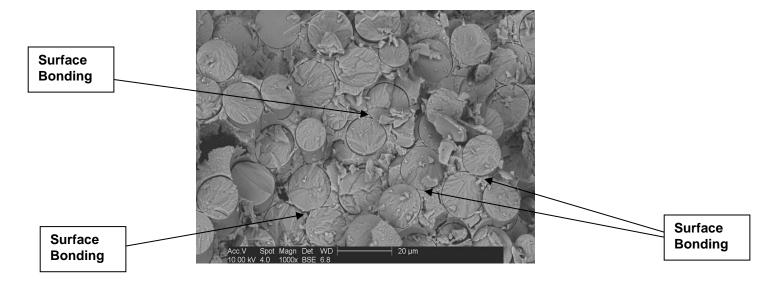
Figure B-1.3.4: SEM Image of 3-D S200, 145 mil @ 1000x. This image illustrate the surface bonding between fibers, which is one of the factors leading to low strength values for this material.

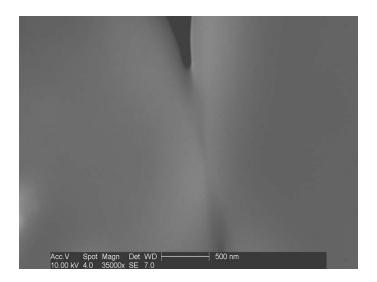
Figure B-1.3.5: SEM Image of 3-D S200, 145 mil @ 35kx. This image shows the surface bonding between the fibers.

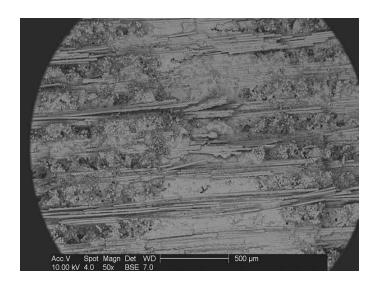
Figure B-1.3.7: SEM Image of 3-D S200, 145 mil @ 50x. Image of fractured surface showing both the fill and tow fibers.

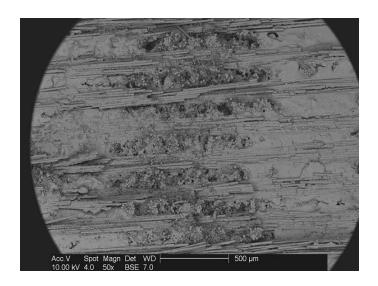
Figure B-1.3.8: SEM Image of 3-D S200, 145 mil @ 50x. Additional image of fractured surface showing fill and tow fibers.

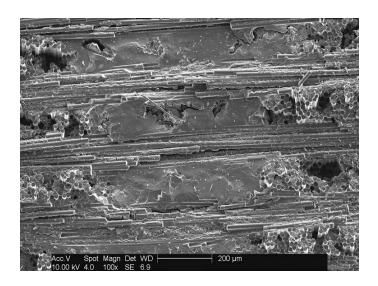
Figure B-1.3.9: SEM Image of 3-D S200, 145 mil @ 100x. Image illustrate step function of tensile failure exist in this material.

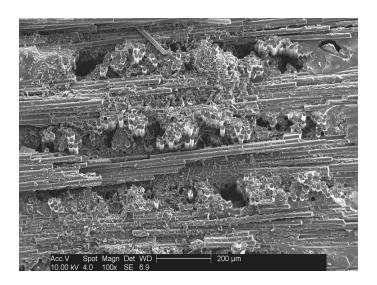
Figure B-1.3.10: SEM Image of 3-D S200, 145 mil @ 100x. Very little fiber pullout...fibers fractured in groups (step function). This characteristics contributes to its poor strength values.

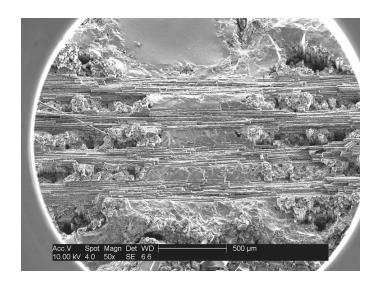
Figure B-1.4.1: SEM Image of 3-D Starfire, 80 mil @ 50x. Image of fractured surface showing fill and tow fibers.

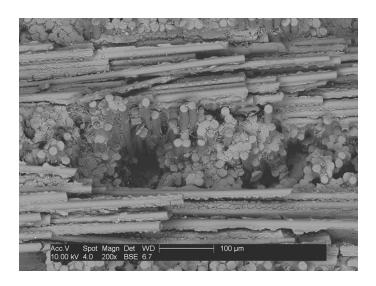
Figure B-1.4.2: SEM Image of 3-D Starfire, 80 mil @ 200x. Poor fiber pull out.

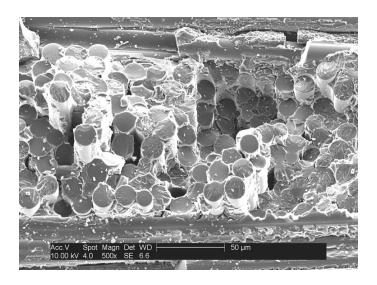
Figure B-1.4.3: SEM Image of 3-D Starfire, 80 mil @ 500x. Image shows the step function in the fractured surface.

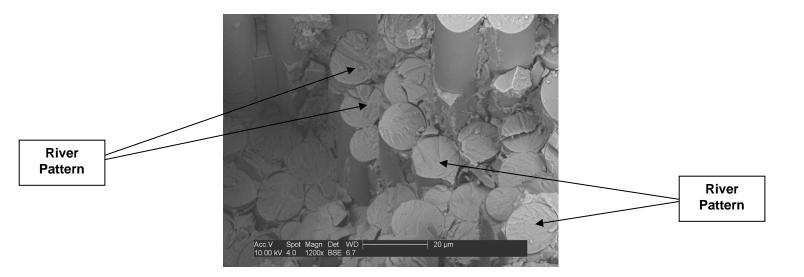
Figure B-1.4.4: SEM Image of 3-D Starfire, 80 mil @ 1200x. This image illustrates the "River Pattern" on the fractured surface indicative of surface bonding prior to tensile failure and the step function of the fractured surface exhibited by all 3-D material.

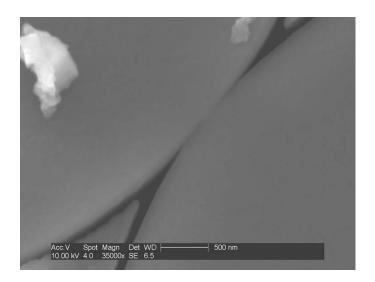
Figure B-1.4.5: SEM Image of 3-D Starfire, 80 mil @ 35kx. Surface bonded leading to low fiber strength.

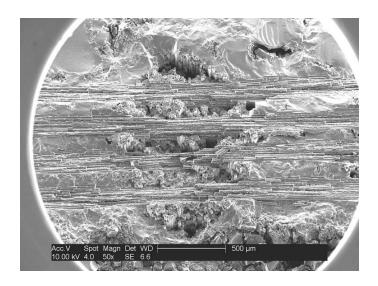
Figure B-1.4.6: SEM Image of 3-D Starfire, 80 mil @ 50x. Additional image of fractured surface.

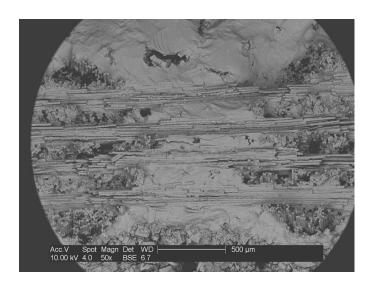
Figure B-1.4.7: SEM Image of 3-D Starfire, 80 mil @ 50x. Step function more pronounced in top and bottom plies of the fill fibers because the warp fibers squeeze these fibers into a wedge shape.

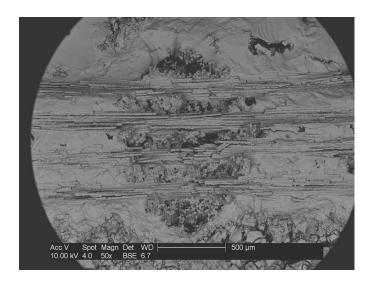
Figure B-1.4.8: SEM Image of 3-D Starfire, 80 mil @ 50x. Good image of fill fibers and some porosity in the matrix.

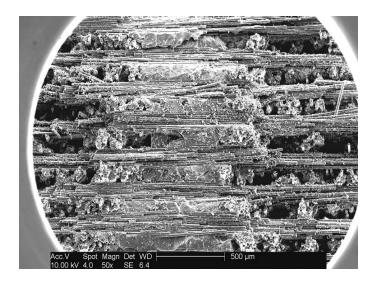
Figure B-1.5.1: SEM Image of 3-D Starfire, 145 mil @ 50x. Image of fill and tow fibers.

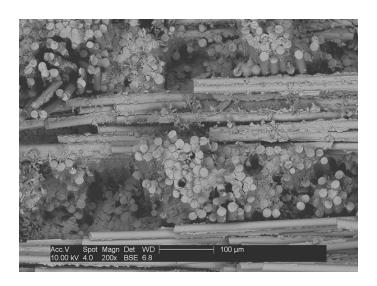
Figure B-1.5.2: SEM Image of 3-D Starfire, 145 mil @ 200x. Good illustration of the step function in the failed fibers and poor fiber poor fiber pull out.

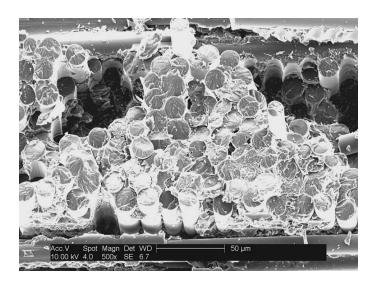
Figure B-1.5.3: SEM Image of 3-D Starfire, 145 mil @ 500x. This image illustrates the "River Pattern" that is indicative of surface bonding leading to low fiber strength and poor fiber pull out.

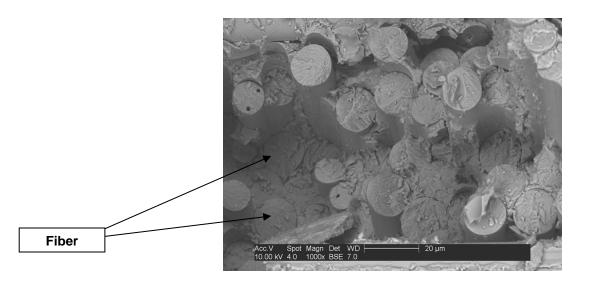
Figure B-1.5.4: SEM Image of 3-D Starfire, 145 mil @ 1000x. Good illustration of the step function.

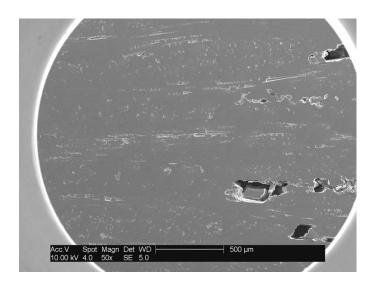
Figure B-2.1.1: SEM Image of Polished 2-D S200-1, 80 mil @ 50x. Some porosity but not much compared to 3-D.

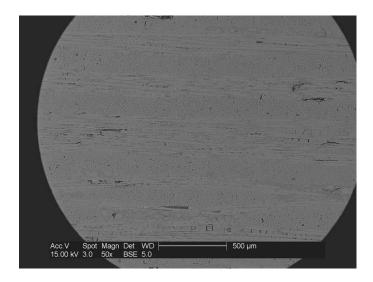
Figure B-2.1.2: SEM Image of Polished 2-D S200-1, 80 mil @ 50x. Typical image of 2-D material.

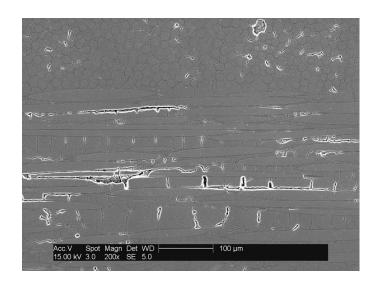
Figure B-2.1.3: SEM Image of Polished 2-D S200-1, 80 mil @ 200x. Image of the fill and tow fibers...very little porosity.

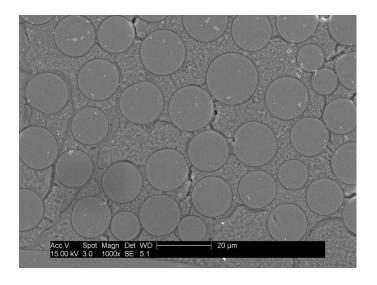
Figure B-2.1.5: SEM Image of Polished 2-D S200-1, 80 mil @ 1000x. Very little to no surface bonding in the 2-D material.

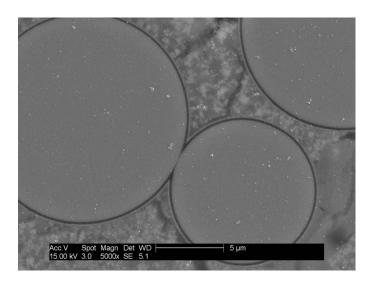
Figure B-2.1.6: SEM Image of Polished 2-D S200-1, 80 mil @ 5000x. Very little surface bonding.

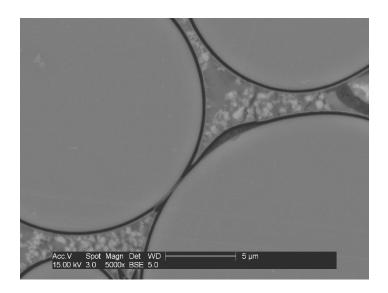
Figure B-2.1.7: SEM Image of Polished 2-D S200-1, 80 mil @ 5000x. Most of what appeared to be surface bonding in 2-D material was not.

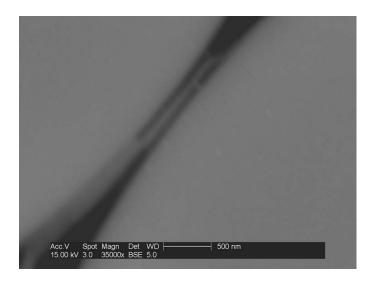
Figure B-2.1.8: SEM Image of Polished 2-D S200-1, 80 mil @ 35kx. Most of what appeared to be surface bonding in 2-D material was not.

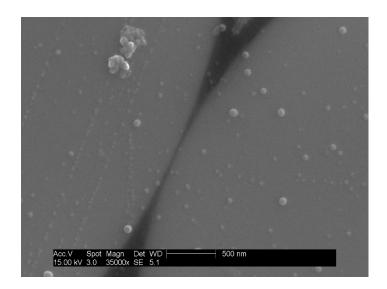
Figure B-2.1.9: SEM Image of Polished 2-D S200-1, 80 mil @ 35kx. Additional image faux surface bonding in 2-D material was not.

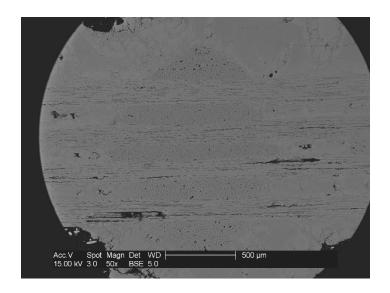
Figure B-2.2.2: SEM Image of Polished 3-D S200-1, 80 mil @ 50x. Some porosity...more than 2-D material.

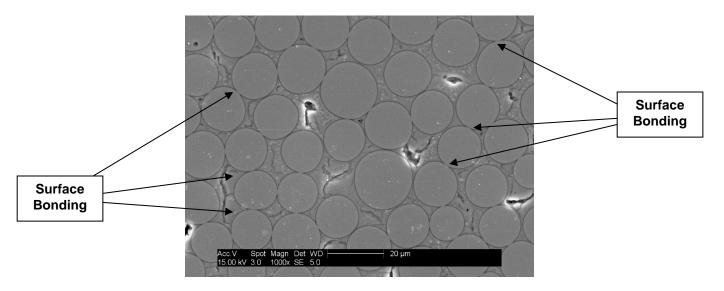
Figure B-2.2.5: SEM Image of Polished 3-D S200-1, 80 mil @ 1000x. Excellent illustration of surface bonding.

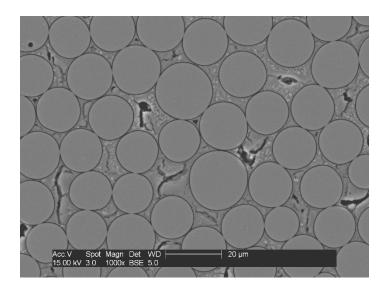
Microstructural studies of polished cross-sections and fracture surfaces confirmed that the 3-D systems had poor-quality coatings. Many of the fibers were bonded together during processing and resulted in brittle-looking fracture surfaces and lower performance in tensile, creep, and fatigue.

Figure B-2.2.6: SEM Image of Polished 3-D S200-1, 80 mil @ 1000x. Excellent illustration of surface bonding.

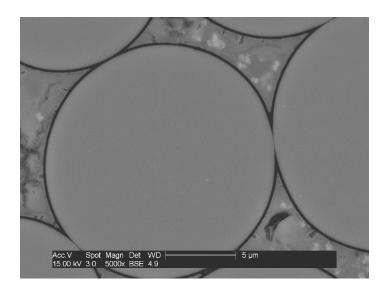
Figure B-2.2.8: SEM Image of Polished 3-D S200-1, 80 mil @ 5000x.

At the same magnification as 2-D, more fibers are captured showing surface bonding.

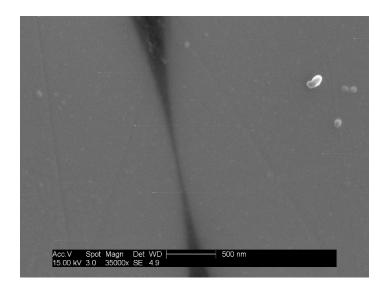
Figure B-2.2.9: SEM Image of Polished 3-D S200-1, 80 mil @ 35kx. Illustration of surface bonding.

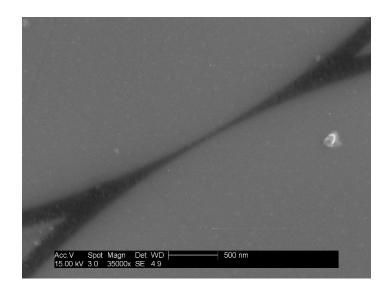
Figure B-2.2.10: SEM Image of Polished 3-D S200-1, 80 mil @ 35kx. Surface bonding.

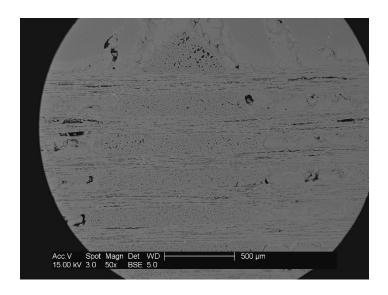
Figure B-2.3.2: SEM Image of Polished 3-D S200-1, 145 mil @ 50x. Image shows porosity in this material.

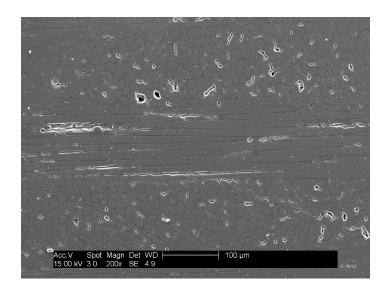
Figure B-2.3.3: SEM Image of Polished 3-D S200-1, 145 mil @ 200x. Porosity throughout this material.

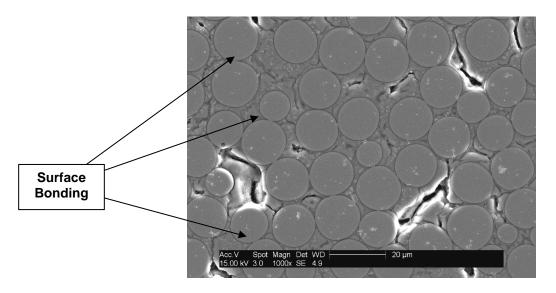
Figure B-2.3.5: SEM Image of Polished 3-D S200-1, 145 mil @ 1000x. More surface bonding and porosity exhibited in this material.

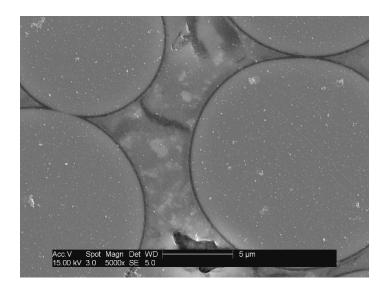
Figure B-2.3.7: SEM Image of Polished 3-D S200-1, 145 mil @ 5000x.

Good image of surface bonding.

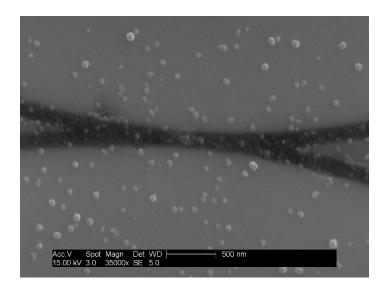
Figure B-2.3.9: SEM Image of Polished 3-D S200-1, 145 mil @ 35kx. Image showing that some fibers that appear to be touching was not; however this is the case 10% of time.

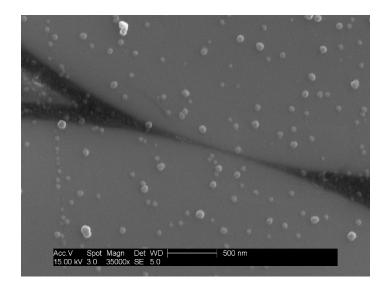
The 3-D fiber preforms needed better fiber coatings. Microstructural analysis clearly showed that fibers were touching each other and there was no matrix and/or coating between a significant number of them. During the high-temperature processing, many of these touching fibers bond together and result in lower-strength composites.

Figure B-2.3.10: SEM Image of Polished 3-D S200-1, 145 mil @ 35kx. Image showing that some fibers that appear to be touching was touching which is the case 90% of time.
